BEV WR5 Baby Jane restoration / recommissioning - Andy Kempen – Latest Report

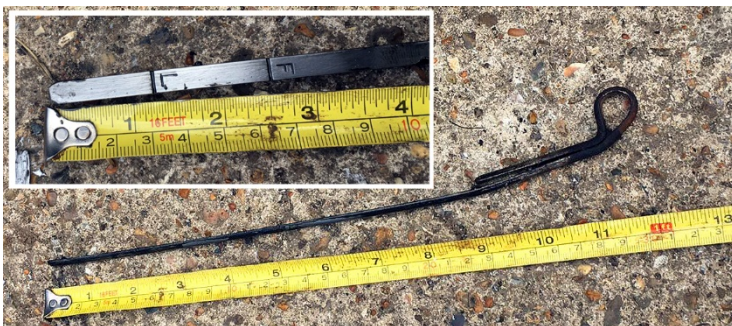
Mention was also made in the previous article of the final drive gearbox dipstick, other railways with WR5 locos that I reached out to all came back to us with assistance (where they had a dipstick, as some found they are in the same boat as with it missing!) those that had one were able to remove their dipsticks and photographing them beside a tape measure so I could see how it should be, as seen below.

Using all the photos from both Richard Faust Fellows at the Great Bush Railway and Ben Coulsen at the Lea Bailey Light

Railway I have been able to create an engineering drawing that will let us manufacture a dipstick when some suitable material or an existing old car dipstick that can be cannibalised and adjusted to the correct dimensions, is found, do you have one we could possibly use? it would need to be just over a foot long.

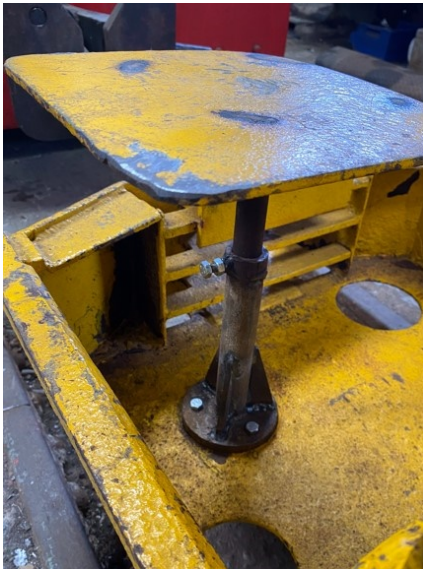
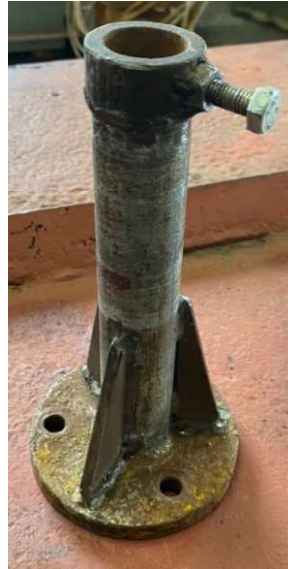
When Baby Jane was first tested the need to fix and fit the seat was also discussed as holding on and operating the controls was not easy when stood on the footplate. The repair of the original seat was completed as seen below.

When restoration started the original seat stem tube was broken off from the attachment plate and the adjuster and stem were seized solid inside. After the old tube was removed from the stem by Ed with the gas axe, a new stem tube was made and welded to the attachment plate, this time with gussets to make it stronger. The original adjuster was removed, re threaded for a larger clamp bolt (the original had to be drilled out) The actual seat probably never had a cushion, perhaps it will get one in the future?

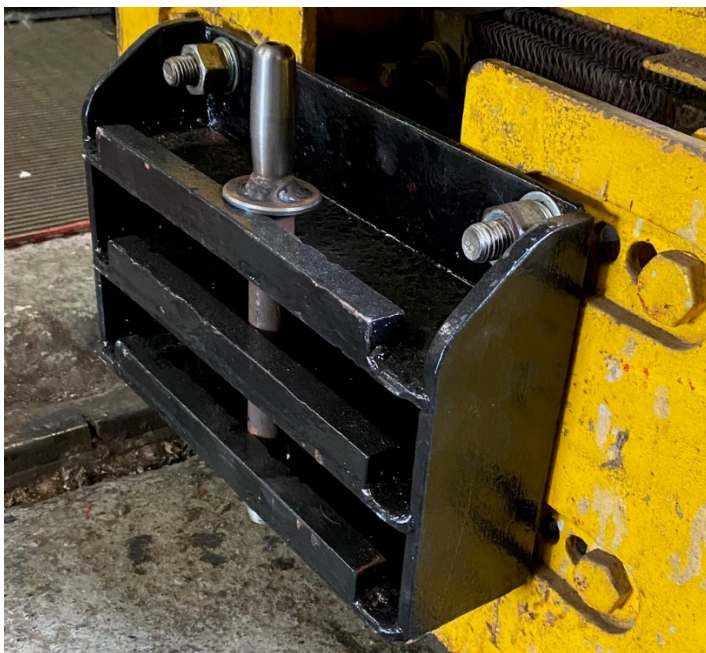
The problem of the overhanging battery box that obscured the coupler and buffer plate had been discussed at some length, shortening the battery box was going to be a massive job. An alternate solution needed to be found. I had noted and voiced that some WR5s came with rubber bumper blocks, but that would not of solved the coupler problem. I did however find one photo in some Wingrove and Rogers publicity material that showed a WR5 with a cast coupler/buffer block fitted to the front plate, one of those would solve both problems. The problem would be finding a suitable one but this was solved when one was fabricated by Ed and Charles, it can be seen below freshly painted and attached.
