BEV WR5 Baby Jane restoration / recommissioning - Andy Kempen – Part 2 & Lockdown 2 update.

Lockdown 2 Update

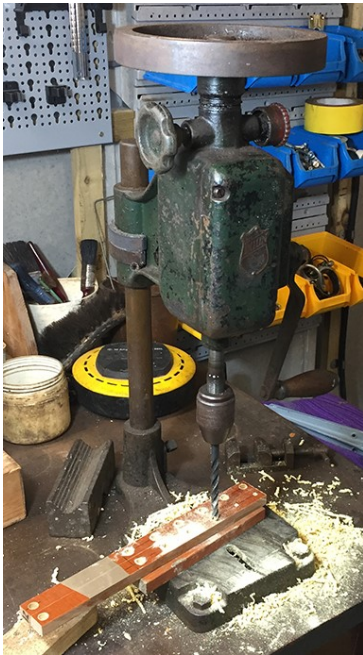
Following my re-measurement of the control box, I was able to complete the first stage of construction of the contactor housing for which I had designed and machined the end plates before lockdown 1. This involved marking out, cutting and drilling the insulating Tufnol. I was able to do it in my own workshop at home, using my Grandfathers turn of the century hand-cranked pillar drill with hydraulic feed, shown in the picture.

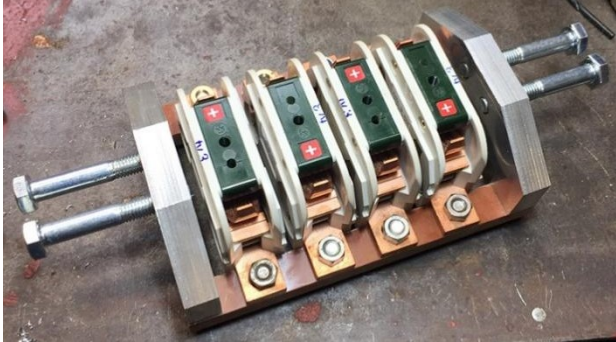
The end plates hang off two support brackets around the cam spindle in the control box, the support studs being clamped by some screw down caps, you can see long bolts in the picture below ready to perform the task of the support studs at my next visit to the GVL R Running Shed/Workshop - the correct length of the studs was not yet known.

I was then able to have a trial assembly using some bolts that I had at home, although they were of the incorrect length, not having enough thread to allow the cable terminals to attach, but good enough to try out the fit.

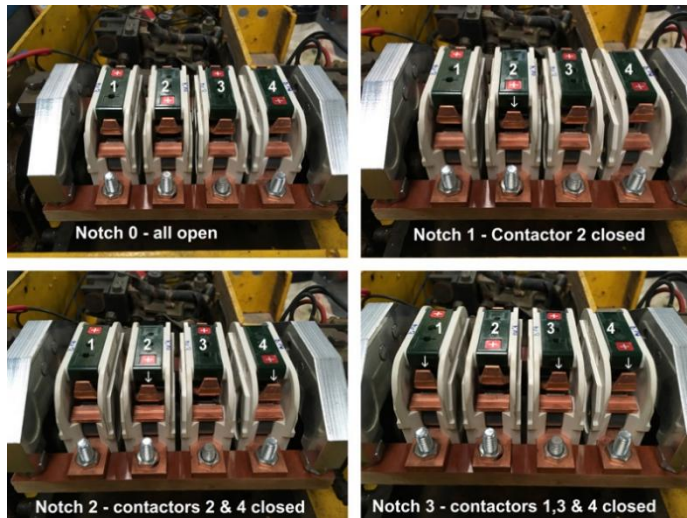
Below, if you look closely, you can see the operation sequence of the assembled contactors in the control box.

When the Arc Chutes arrived, I arranged a further visit to the Works for another trial fitting session. I had made the support studs at home so this time a complete fitment could be made to allow an exact measurement to be taken from the cam in the control box to the contactor switch roller plunger.

I had made my design of the contactor carrier so when fitted the roller plunger was close but clear of the cam in the open/up position, so precise positioning could be achieved and allow provision for

adjustment due to wear by using spacers & shims. An initial spacer would have to be made to ensure the correct 4mm working stroke was achieved without exceeding the additional 2mm free stroke of the contactor. I used a series of small drills of known diameter until I found one that just dragged on the sprung roller plunger to measure the exact gap size, added 6mm and the answer by simple maths gave the required spacer thickness – as it happened I was able to find some loose nuts of the correct thickness to perform as temporary spacers so a full operational trial was possible.

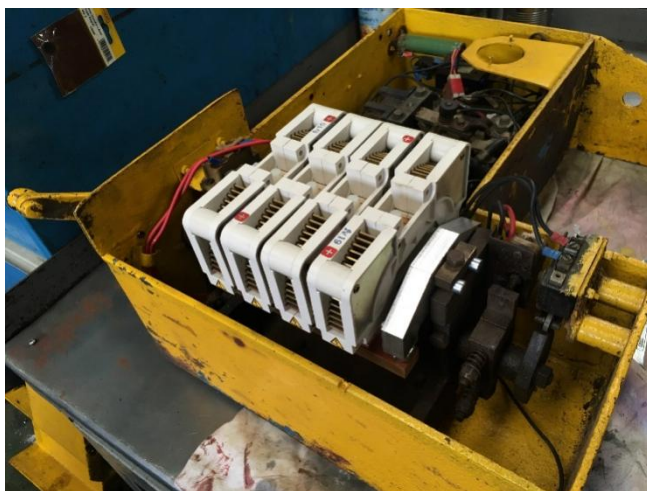
Once this has all been done the control box lid will be trial fitted and modified where needed as the Arc Chutes will be a very tight fit, maybe too tight – this can be seen in the final picture of the fully assembled controller below.

You can also see from that picture that the battery condition gauge is missing, it should be in the large round hole to the top right of the image– I am on the hunt for one of those currently as well.

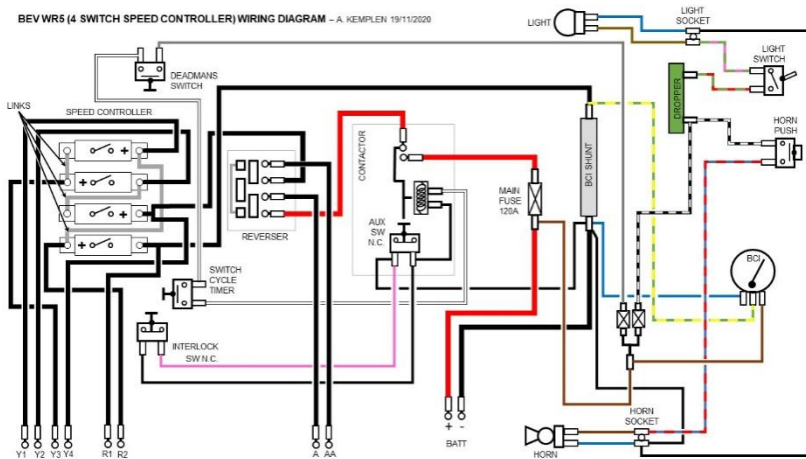
I did careful study and testing of the internal low current control wiring, then using the original wiring information that we had and the drawings from Brian I produced a wiring diagram correct for Baby Jane.

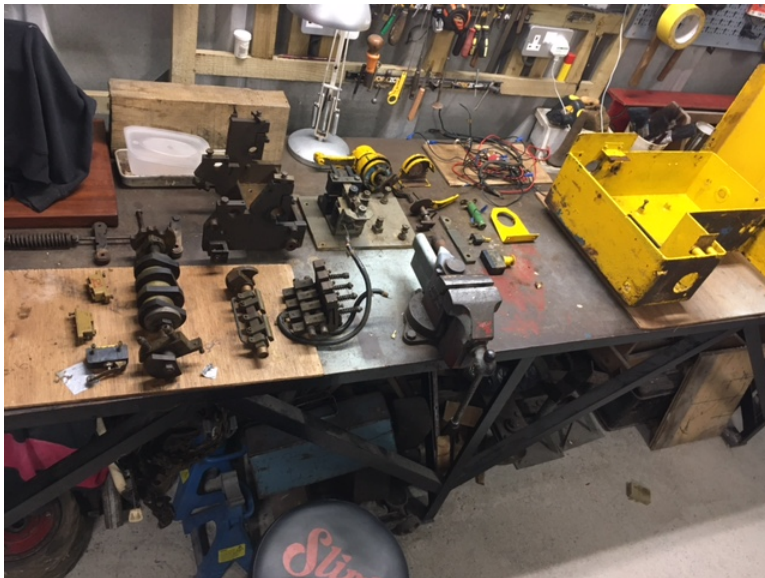
I now felt comfortable that I would be able to correctly re-assemble it having a diagram, so I proceeded to strip it completely to pieces ready for cleaning and renovation, as seen in the next image.

When taking it carefully apart a few problem areas were identified such as a sticking micro switch, an out of place bushing piece on the

cam shaft and there was also a small actuating rod inside the Deadman handle that was crudely made from an over long old screw, down the mine running repairs? (probably the cause of the misplaced bushing).

Upon close inspection of the sticking switch it was found to have a broken and cracked casing, I was able to read off it though a manufacturer and part number, Craig and Derricott Ltd, A2A 20A - after a bit of online searching I found the exact part available 'New Old Stock' on e-bay, for just £10.00 with free postage ! – it has been ordered - interestingly the horn push button which is also made by the same manufacturer has a date stamp sticker of 06/79.

My next major task after the cleaning and reconditioning of all the components will be to make up a new internal control wiring loom, test and refit the contactors and also test them.
