BEV WR5 Baby Jane restoration / recommissioning - Andy Kemplen – Control Box Latest Report

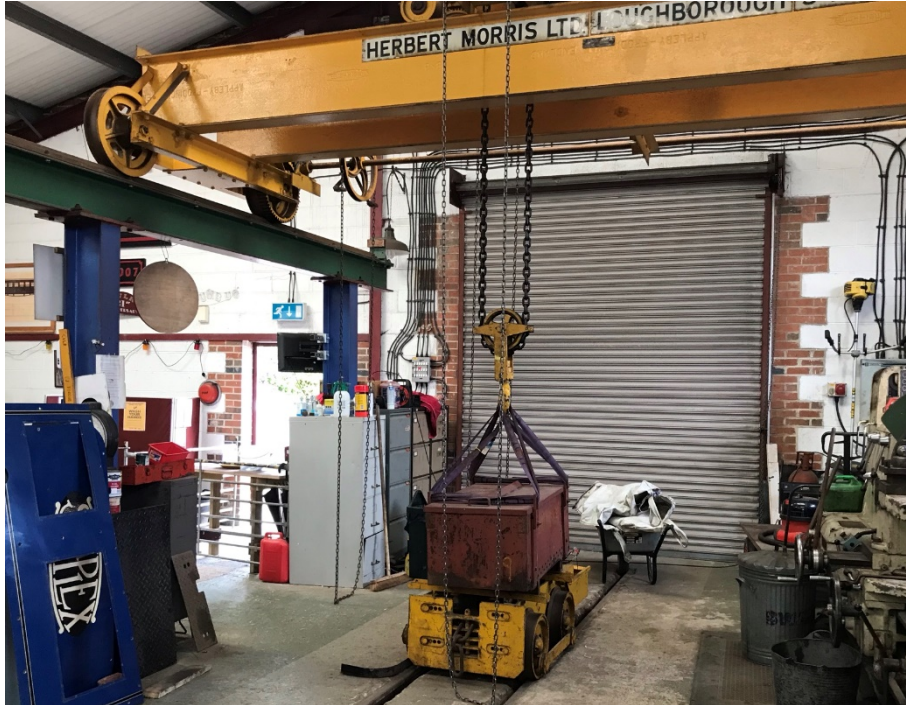
In the last instalment I was left with some uncertainty as to which main cable was which with regard to R1 and R2. Further investigation was needed; As you can see below one summer Sunday whilst I was Shedmaster, I set to and had a deeper look.

With its weight taken on the overhead crane the battery box was easily slid to the side and then lowered to the ground, giving clear access to all the cable runs as can be seen in the following image.

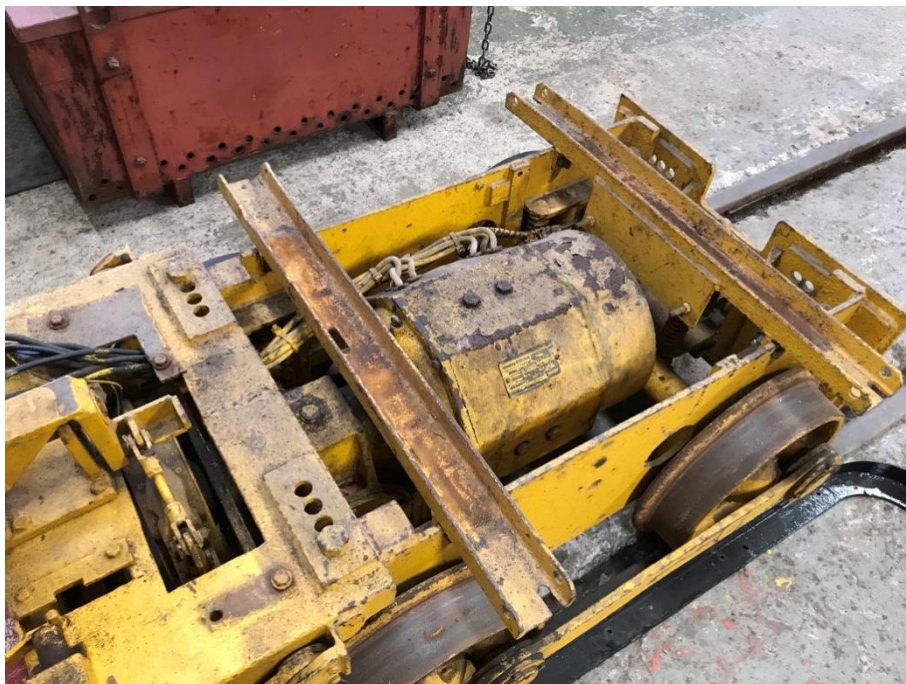
.... it was then easy to trace and see which cable went to which resistor. The electric motor is also clearly visible along with its cables, as is all the running gear.

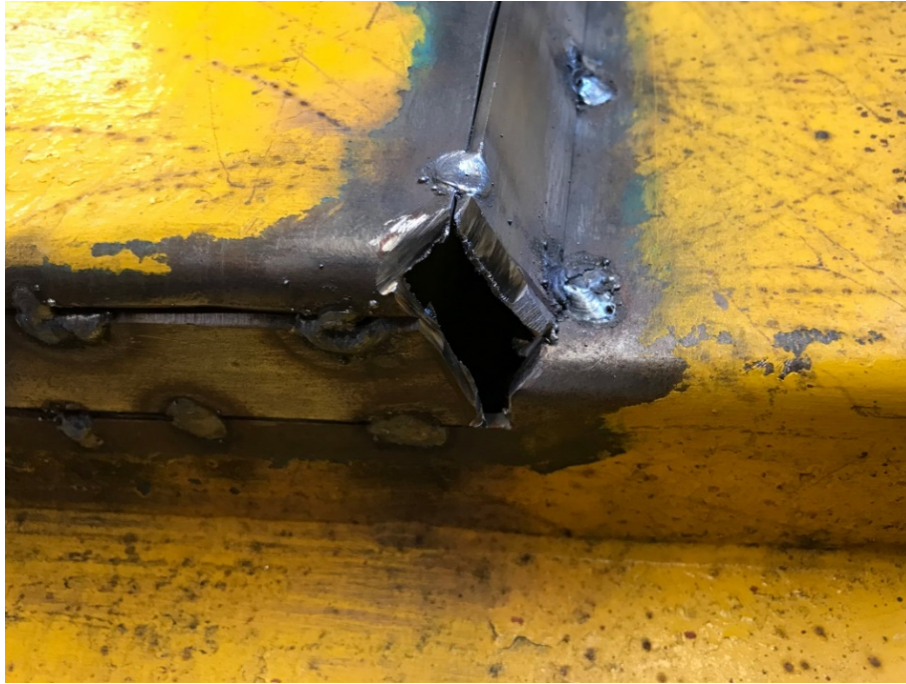
The other thing left over from the previous instalment was that I had started work on the 'bulge' to the lid for the control box so as to clear the arc chutes that have been added to the new Schaltbau contactors within it. This had left us with an open cornered bulge with the sides tacked into place, as below –

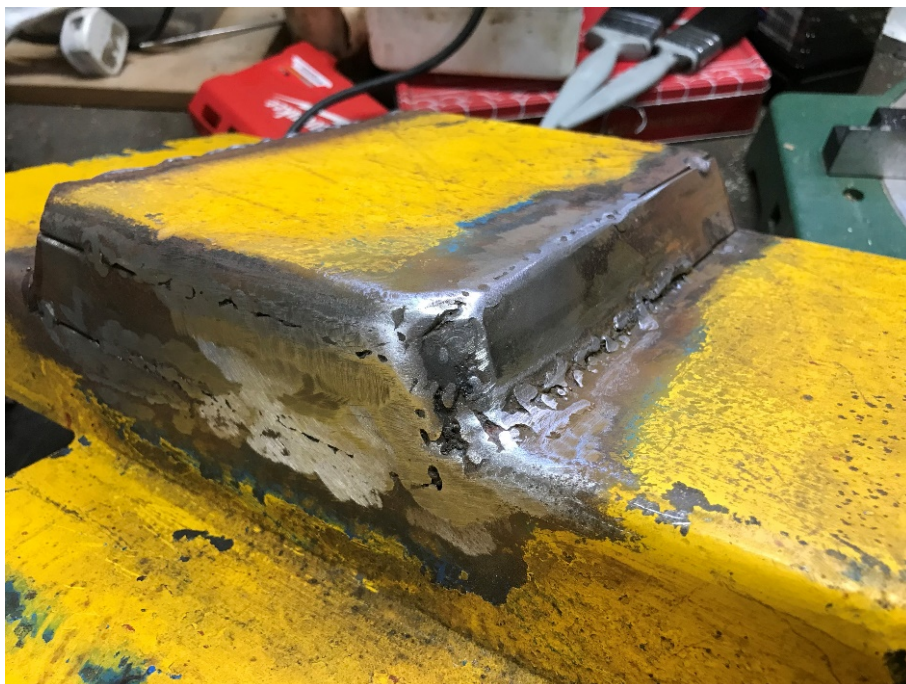
Earlier in the year I made one of the corner pieces and welded it (not very well) into position. This had left me a little frustrated, as to me it was not a good enough job, I was not overly impressed with my welding, using my dad's old MIG welder but when it was ground back it had done the job of fastening it together, just ! – this can be seen below.

I was not totally happy with the result – I used to be able to weld better than that, even with that old MIG welder.

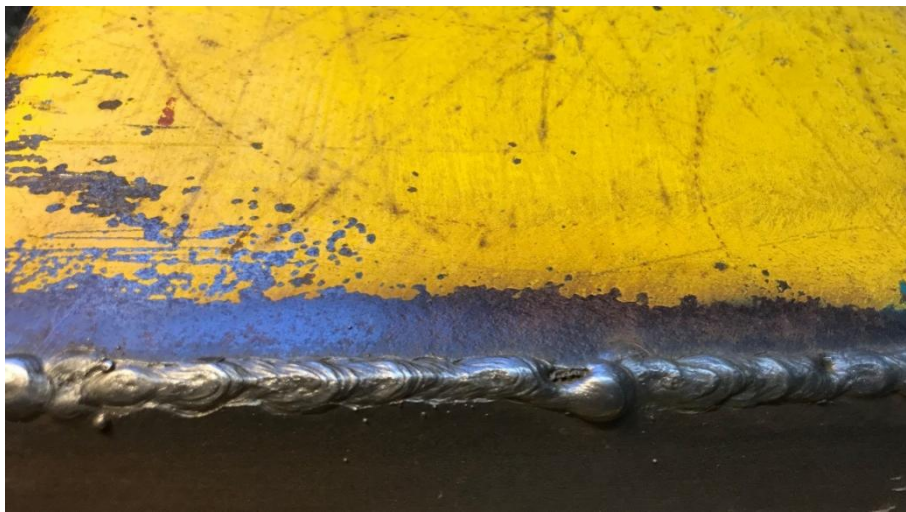
When I got it and tried it out on some scrap metal of a similar thickness to the control box lid, the welds were not quite right, no matter what power setting I used, but it seemed quite easy to use. After some thought and research, I realised that it was the rod size that was the problem and that for the control box lid I would need some different welding rods. I got some better, larger size rods and I had a go at some of the other edges on the bulge with surprisingly better results as you can see below, my weld was nowhere near as slaggy, as with the MIG welder and that only a small amount of grinding would be needed to get it looking more acceptable, in my eyes.

Although I now have better tools to finish the welding, unfortunately I still find myself without the time to have a good session on it to complete it fully, it does not seem such a daunting task now - as we see this year out things will hopefully calm down and I will get it completed ready for the new year.
