BEV WR5 Baby Jane restoration / recommissioning - Andy Kemplen – Control Box Latest Report

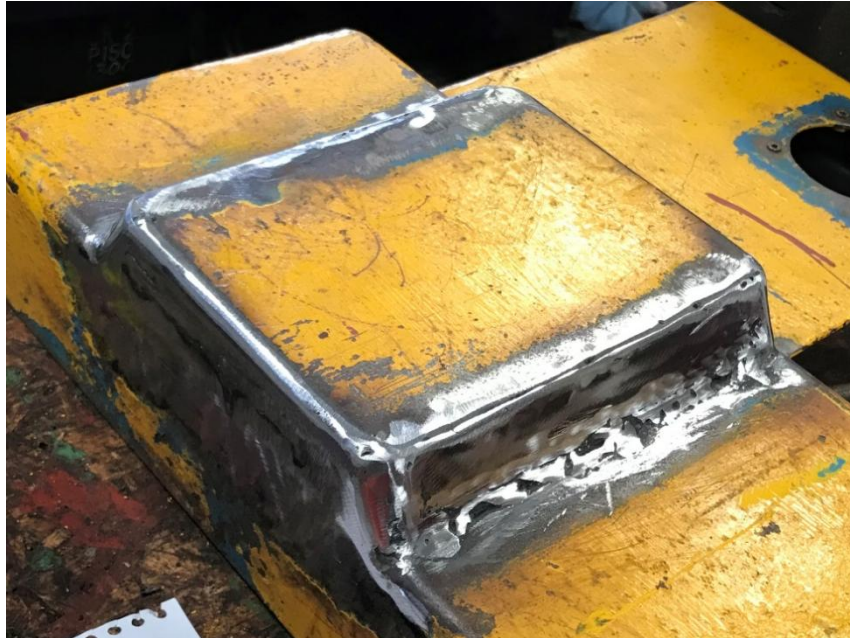
Following on from the previous article about the control box cover the welding of the 'bulge' and its corners were completed, with help from Ed. With an angle grinder I smoothed all the rough edges and weld splash ready for some fibre-glass filler as can be seen below.

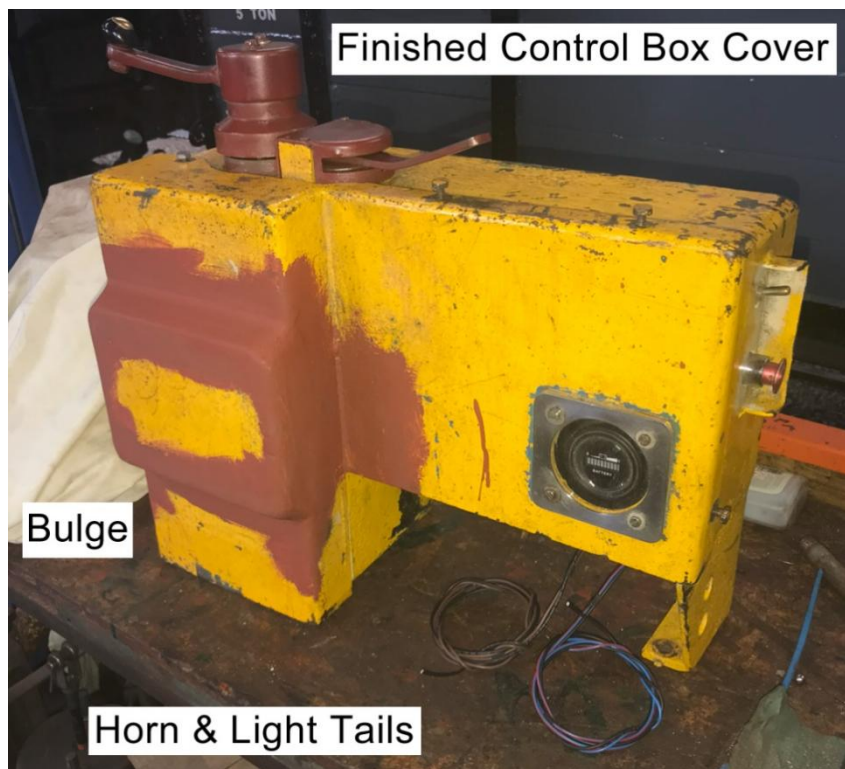
Some fibre-glass filler was added and shaped, followed by some red oxide primer so as to protect the bare metal from rust – it can be seen finished below.

Overall, I am now pleased with our solution to covering up the arc chutes that have been added to the replaced contactors inside the control box, that necessitated the addition of the bulge to the control box cover- I am sure and happy that this should not look too bad when it's all painted.

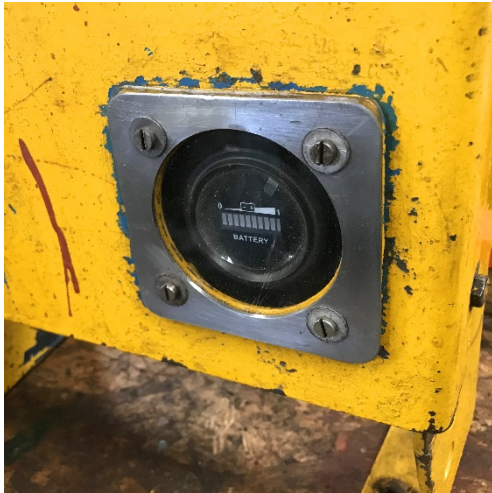
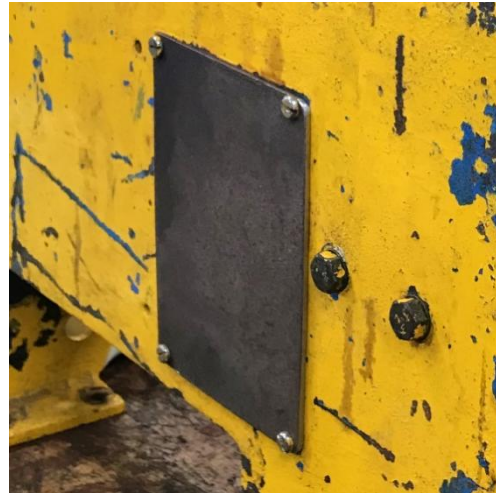
Also, in the cover to the right of the bulge was an window aperture for the battery condition gauge to be viewed through – all we had left of the viewing window for this, stuck in the paint, was a gasket - I have made in the gaskets pattern a frame/retaining plate, out of an old stainless steel door sign, that was in the metal scrap bin that holds a drilled piece of perspex sight glass (provided by Charles) in position as per the original fitment. On the rear of the control box there is an access hole for the reverser cable terminals, the missing cover for this was also made from a piece of sheet steel again from the scrap bin. Two sets of matching retaining screws of the correct thread size were found in the easily accessible plastic wall bins (well done Derek) to attach the covers as shown below.

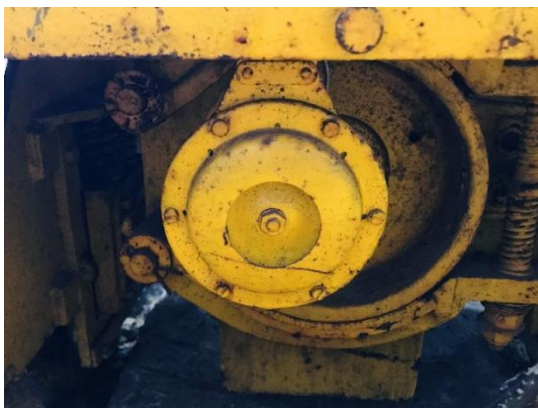
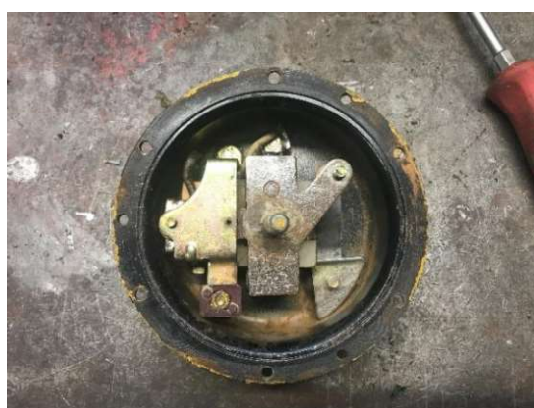
Inside the control box connectors had been included for the light and horn wires to be joined to – I have built up the other ends of these connectors with long tails ready to be connected to each respectively (visible in the second picture of this article) The Horn was removed from the loco and dismantled, it was found to be quite badly corroded inside. I have cleaned it all up and attempted a repair as where one of the wires from the coil inside joined to a tang to accept a cable terminal the tang had turned to powder ! – I am not that bothered if the repair is not successful as modern golf buggies and some other electric work vehicles still use 48 volt horns - so a replacement can be easily purchased for as little as £7.50 from China ! – but I think it probably deserves one of a better quality from a known manufacturer, that looks more substantial, available for under £30. Below the horn can be seen in situ and then with its internals all restored, repaired and cleaned up.

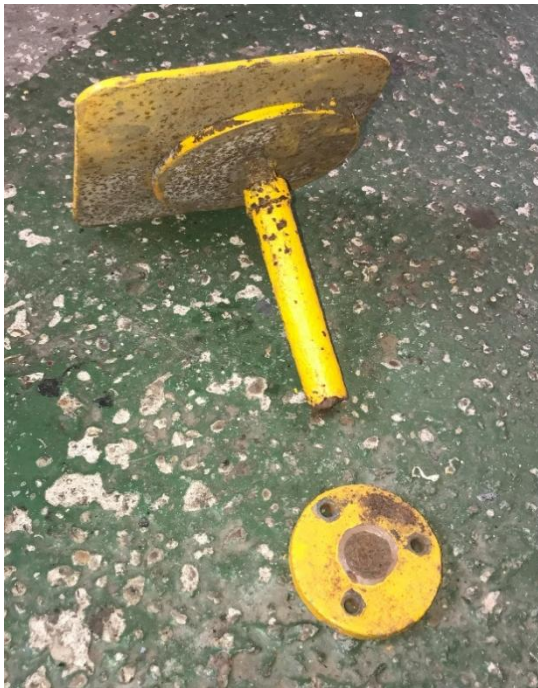
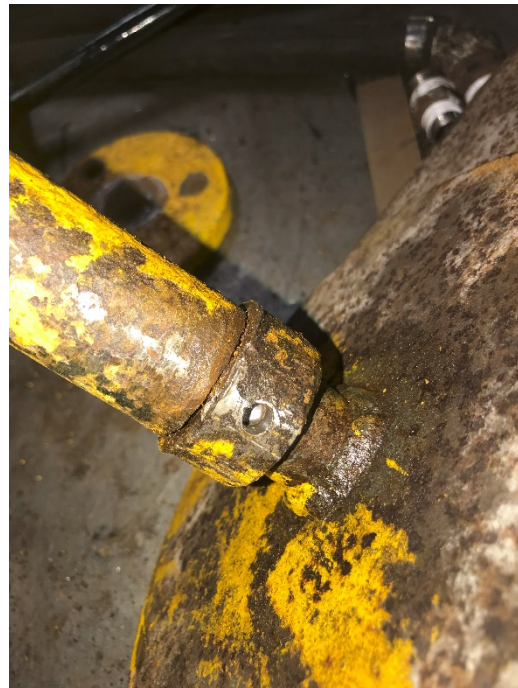
More recently I have started to attempt to release the seat base from its mounting, the bottom of the mounting has rusted off but can be welded back on and the part that pulls out of the base is rusted in - I have drilled out the sheared clamp pin as can be seen below and have managed to move

it a small amount. The seat needed to be removable so the footplate could be folded to allow the locomotive to fit in the mineshaft lift – the seat parts and the progress in separating them can be seen below.

A more suitable, comfier detachable seat may be fitted in the long run as the need to go down a mine shaft probably no longer exists ? !
