BEV WR5 Baby Jane restoration / recommissioning - Andy Kemplen – Latest Report

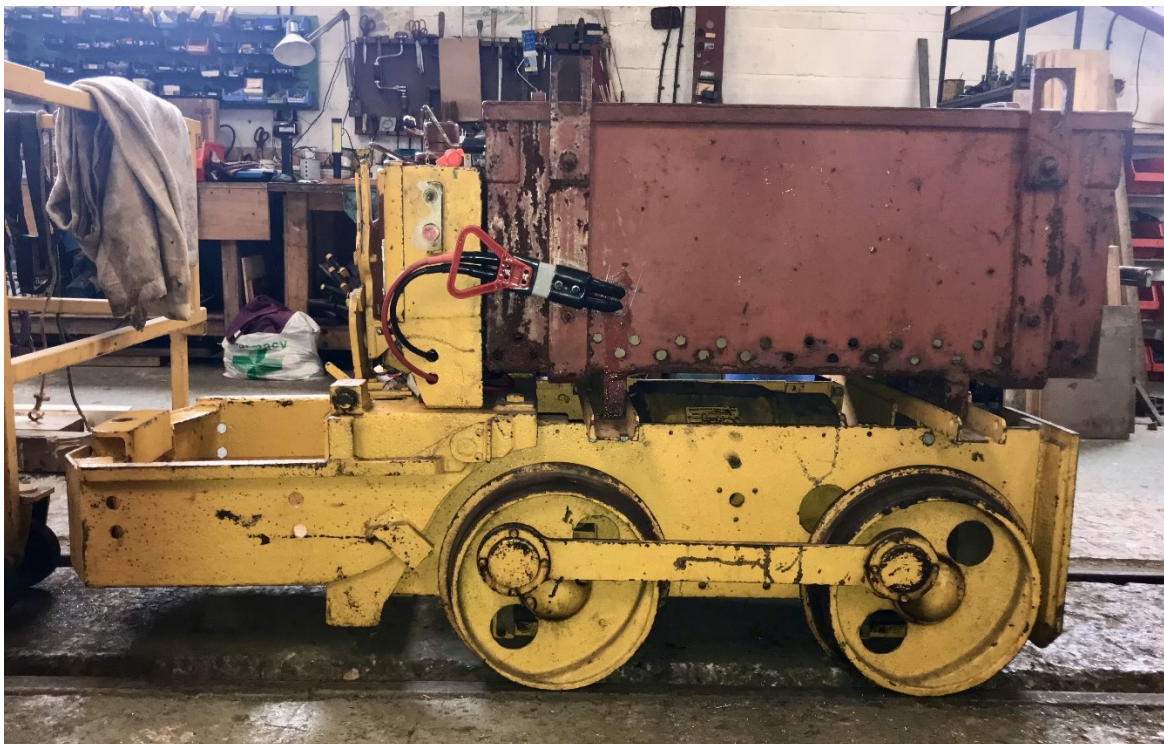
I decided upon the disconnecter location and after a trial fitting, I drilled the battery box side to take the bolts to hold the fixed part of the Anderson connector as seen below.

With it fitted like this it can be disconnected and the entire battery box removed – this is how charging would have been done down the mine, there would have been multiple battery boxes and when you needed to recharge you went to the charging station and just switched over to a charged battery box by sliding the whole box off and a fresh one on, connecting the run down one up to charge before you went back to work; the box can be seen to be sitting in runners that facilitated this, in the above picture.

I have found out that the battery box Baby Jane has, is probably not the original one it had from the factory when new, although it looks similar and performs the same it is dimensionally different to what is shown in the BEV brochure – it is longer and not as high, as there is little or no gap between the battery box and the control box and it overhangs the front buffer plate. This became evident when I was planning the location of the connector as originally it was on the rear face of the battery box but we could not put it there as it would not fit, you can see its size in the above picture also.

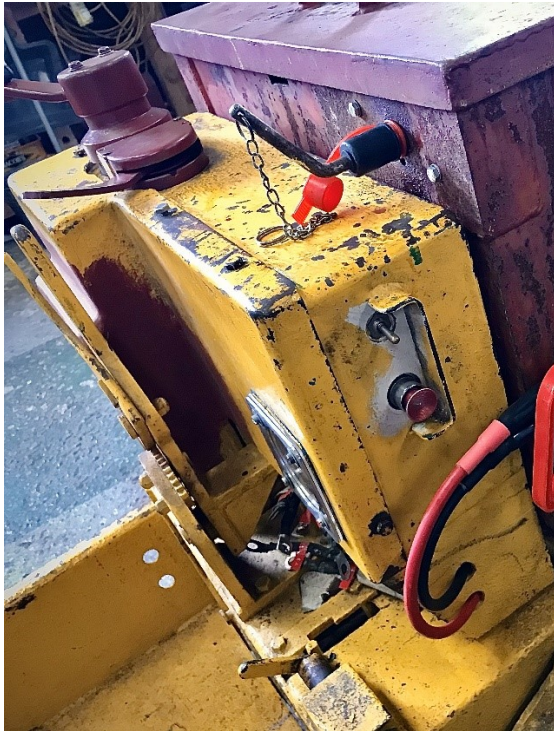
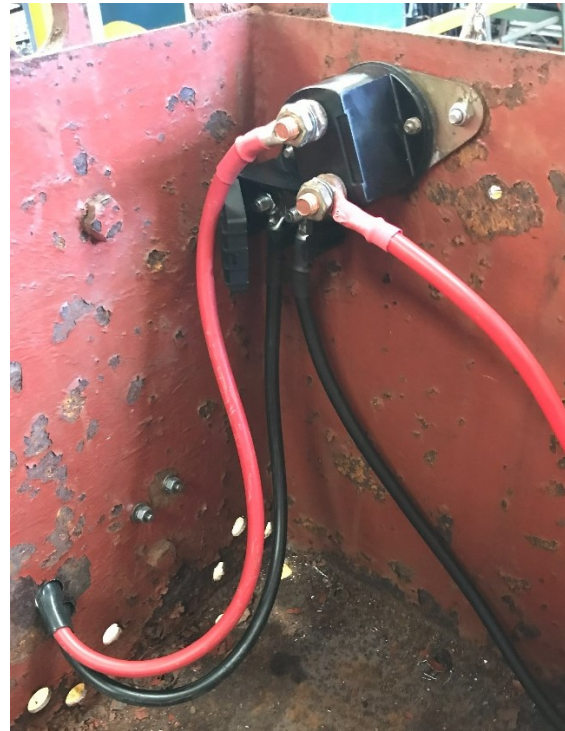
There was however enough room on the rear face of the battery box to add the emergency stop/battery isolator switch, that I fitted next, it can be seen in the following pictures.

I have since these photos were taken ordered grommets for the holes in the battery box to stop the cables chaffing, we don't want a big flash bang when she is in use !

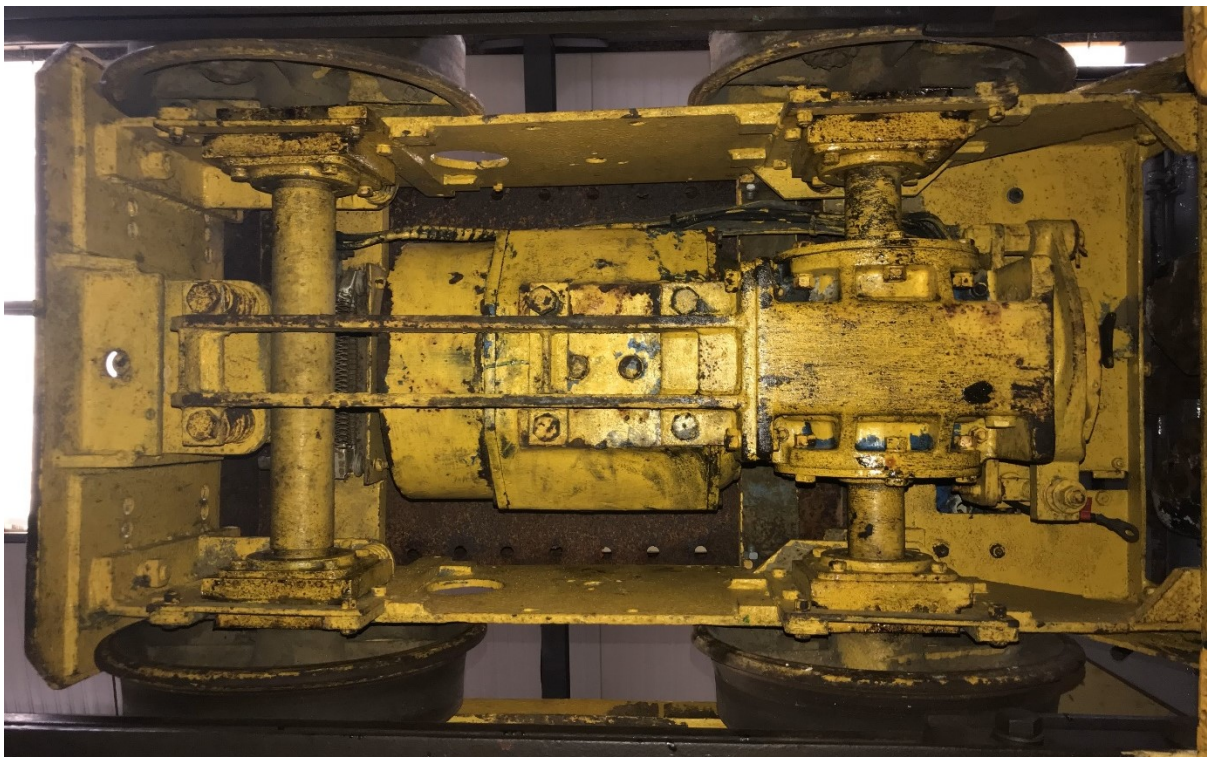
As an aside, one morning when I was shed master I found Baby Jane over the pit and took the opportunity to snap the following picture, interesting to see it from this view I think ?

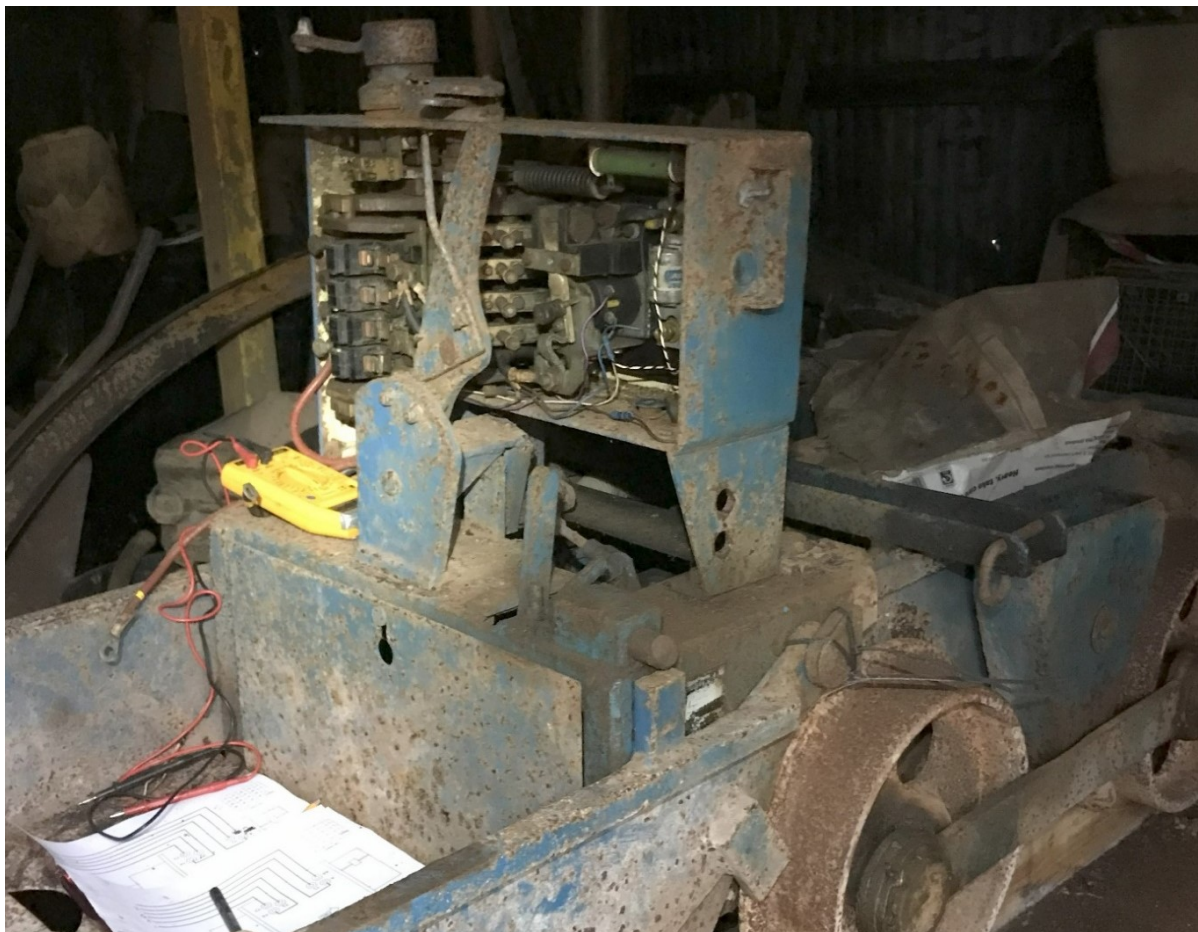
When we arrived and everything was unlocked, I had a short tour of their facilities and chatted with Ben about their BEV WR5 – it turns out that the iron mine on which the Clearwell Caverns attraction is situated was its original home. In a shed their BEV WR5 was up on blocks having had final drive problems in 2020, this meant that the battery box was off and access to the motor wiring was good and I was able to probe the cables with my meter, take notes and photos to see how it was wired – here is a picture of the loco as I was testing and mapping out its cables in the shed

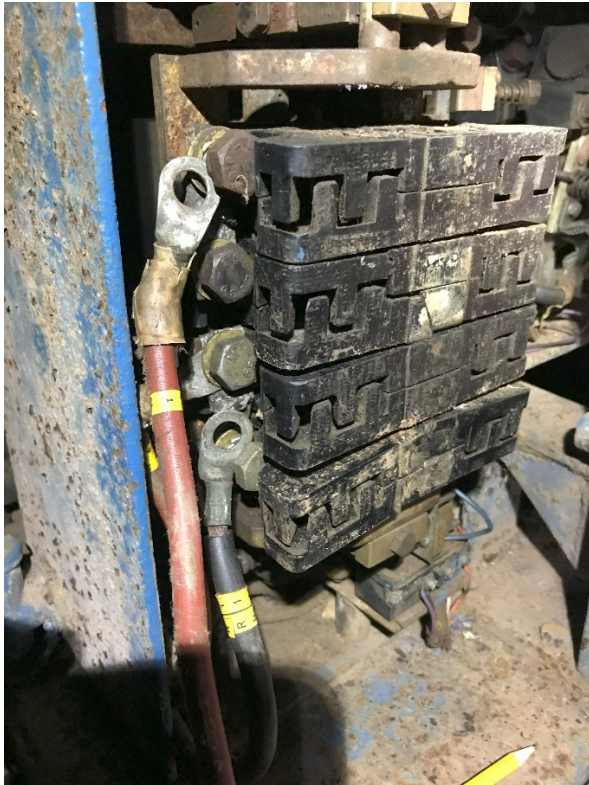
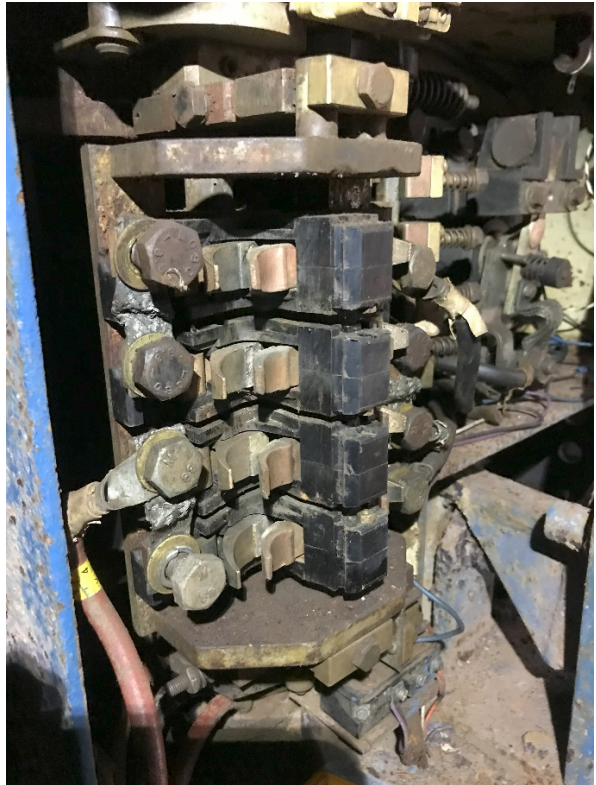
I have also included these shots of the original Sevcon Contactors, that are rarer than hens teeth, the second with the arc chutes removed.

It was interesting to see that the interior of the box was painted cream like Baby Janes and that the links between the contactors were made of a braided flat wire like a battery earth strap, not copper plate like I had used for ours. The contactors worked in an identical order to ours for the three speeds so the cam was the same, All the motor wire positions where they exited the motor were the same as I had worked out, although the '3' tag had dropped off one of the field winding cables, so they were labeled Y1, Y2, Y and Y4 - the link positions and the Y cable contactor positions were noted on a sheet I had prepared. The R1 and R2 cables were positioned exactly as ours, as was the shunt (battery negative) - the position of the cable from the reverser (battery supply) was also noted.
