## BEV WR5 Baby Jane restoration / recommissioning - Andy Kemplen – Latest Report

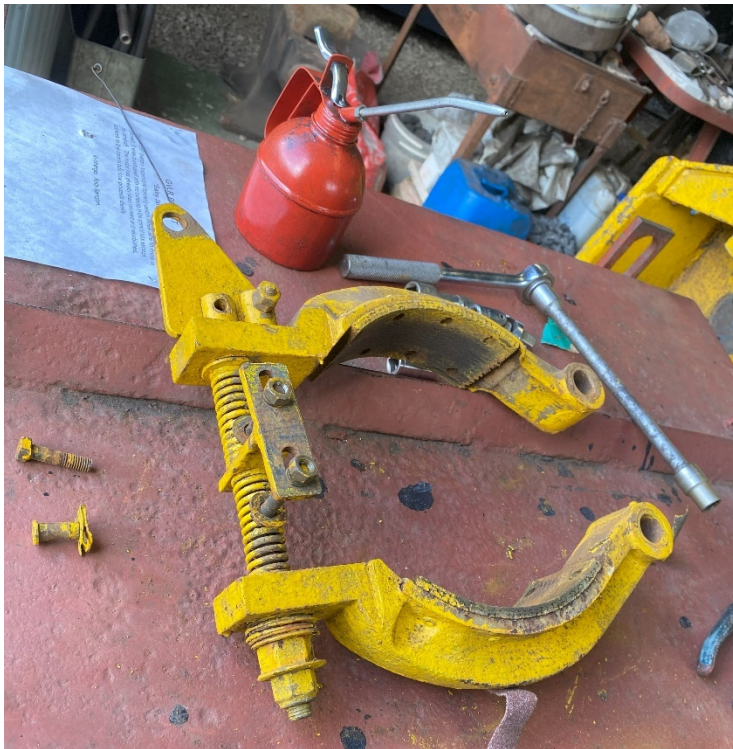
At the end of the previous article, it was noted that there was a problem with the brake so this is where I started my next session of further work. It had been seen that it did not work very well and needed investigation and probably remedial work, so the mechanism was removed from the loco.

I took the whole assembly home to my workshop and proceeded to fully disable it. When inspected it was clear that it had not been working properly as one of the brake shoes was un-worn and had not been contacting the drum at all!

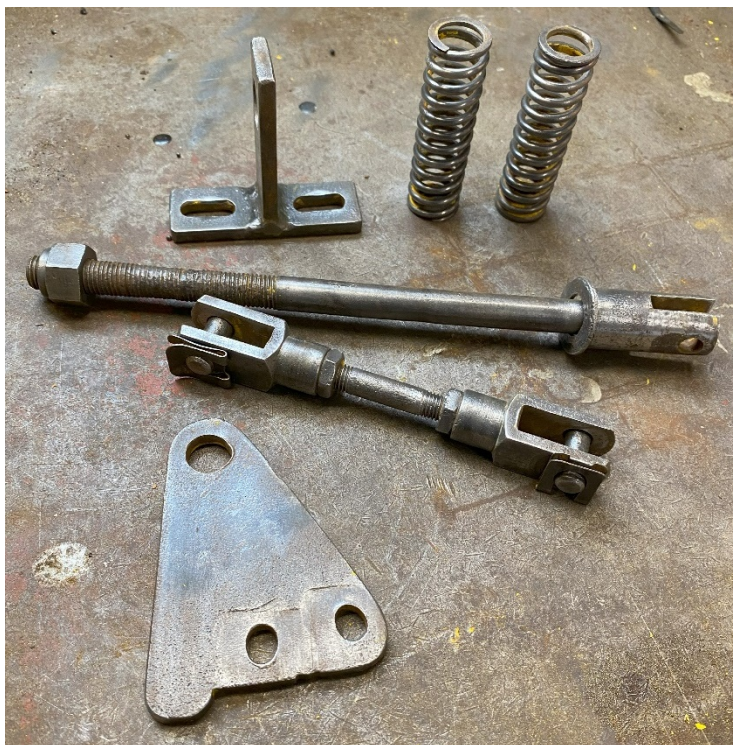
Also the Brake Spring Rod was found to be rusty and seized plus the holes in the Brake Lever pivot plate were found to be very worn – the egged-out holes in the plate (as seen below) would need to be repaired and new pins sourced.

It was found that the pins were the same size as used on a Massey Ferguson tractor so were easily obtained. I next set about making the holes the correct size for the pins. This was to be done by welding a nut into the plate and then drilling out to the correct size. I first opened out the holes and ground a chamfer on the edges then drove the nuts in and welded them into position on both sides of the plate. The plate was then ground and filed flat before the holes were drilled out to the correct size for the newly acquired pins.

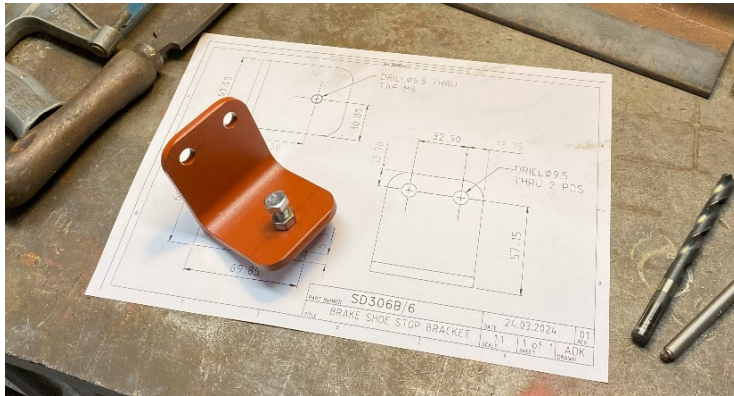
Upon consulting the Operator's Manual 'Brakes' section it could be seen that to correctly adjust the brakes an adjustment stop screw was to be used, this was found to be

missing from Baby Jane along with its bracket. I measured the mounting holes, and worked out where the screw needed to sit so a drawing could be produced. I then made a new bracket from a piece of angle iron that was procured from the scrap pile.

Upon my next visit to the Running Shed the whole system was assembled and set as described in the adjustment procedure in the Operator's Manual, now when operated it was pleasing to see both shoes move and make contact with the drum, it was as good as new.
