## BEV WR5 Baby Jane restoration / recommissioning - Andy Kemplen – Latest Report

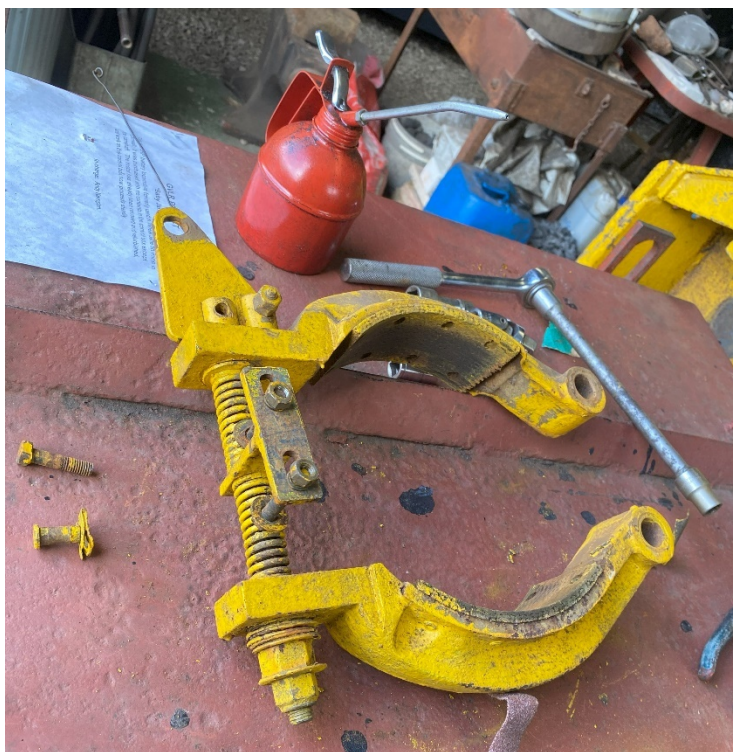
At the end of the previous article, it was noted that there was a problem with the brake so this is where I started my next session of further work. It had been seen that it did not work very well and needed investigation and probably remedial work, so the mechanism was removed from the loco.

I took the whole assembly home to my workshop and proceeded to fully disable it. When inspected it was clear that it had not been working properly as one of the brake shoes was un-worn and had not been contacting the drum at all!

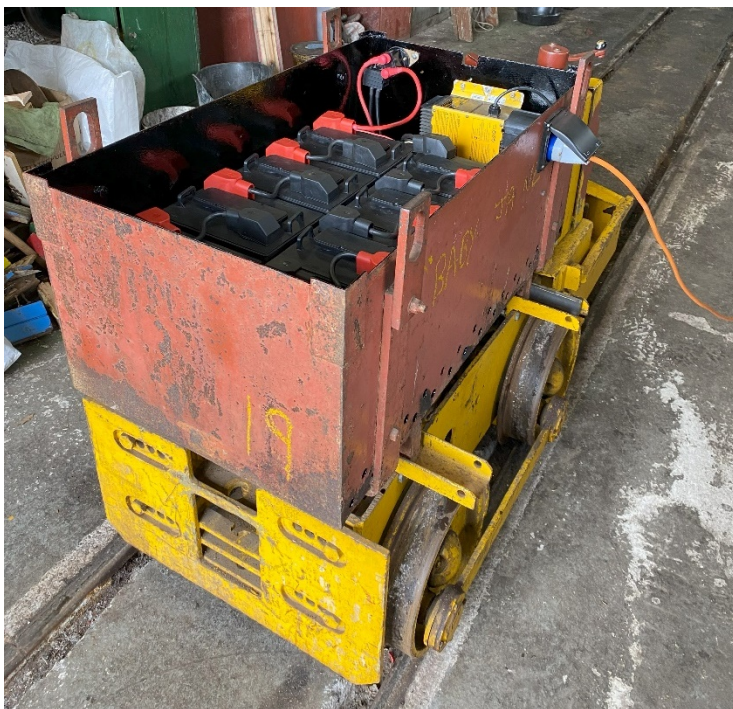
Once all the drilling and fitting out was done and a trial fitment was successfully completed all the batteries, charger, hold down clamps and connector were removed and the inside of the box was painted with an acid proof bituminous paint.

Now completely reassembled, the loco can be easily charged by just plugging in to a 240v supply with a commando connector as seen above.
